Jetter

**Technical Information
Version Update**

June 15, 2005

**JX6-CON1 / JX6-CON+ Modifications
from Version 3.001 to Version 3.033**

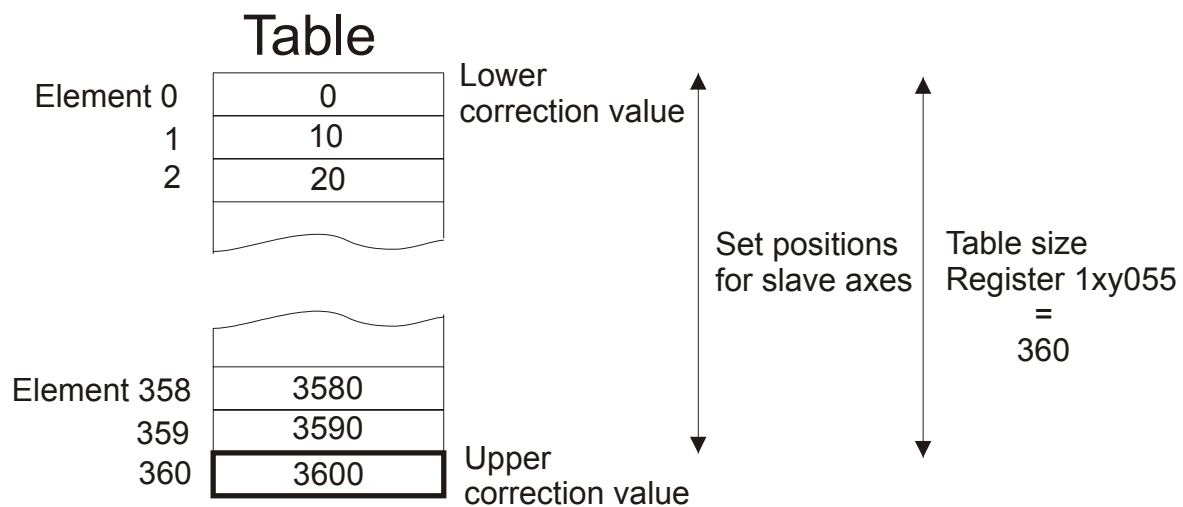
- (3.001) Using the acceleration limitation (register 60) with the follower only worked in one direction.
- (3.002) When recording the actual position in JetSym or Sympas oscilloscope mode, the values might have been incorrect.
- (3.003) Starting from version 2.900, an error might occur when creating a table if a table was written before using a too extensive table pointer.
- (3.004) Starting from version 2.900, the correction value during table mode overflow applied to the last table element. Starting from this version, the correction value must be entered again as additional element:

The correction value in case of table overflow is calculated as follows:

Correction value

= Value of the table element (register 1xy055) – value of the table element (0)
 = 3600 increments – 0 increments = 3600 increments
