Jetter

**Technical Information
Version Update**

June 15, 2005

**JX6-CON1 / JX6-CON+ Modifications
from Version 3.001 to Version 3.033**

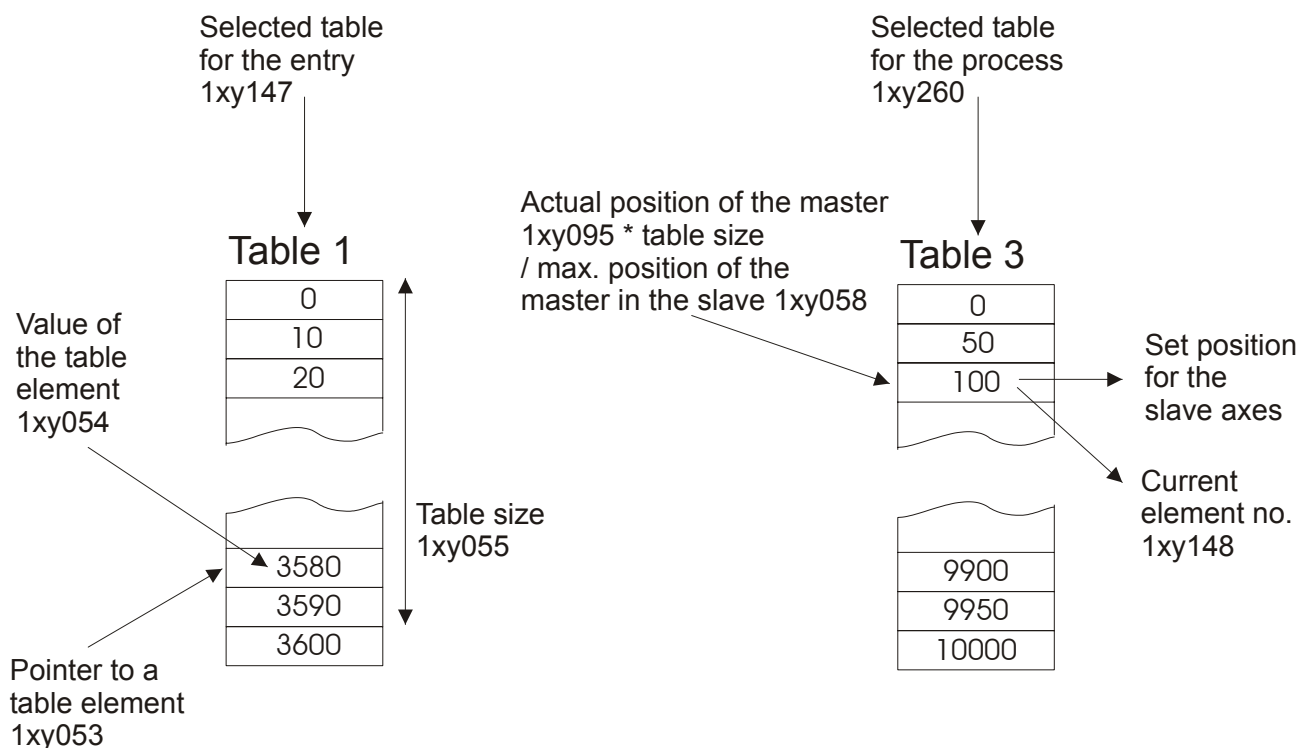
- (3.004) Starting from this version, the tables can be entered and processed separately. This means that it is possible to enter another table while a table is being processed. The new register 1xy260 serves to select the table for the process.

The following diagram illustrates the entry and process of various tables:

As in previous versions, different table sizes are allowed. As long as register 1xy260 is not written, register 1xy147 is used as selected table for the process.
