Jetter

Technical Information
Version Update

**D-CON Changes
Version 2.801 through Version 2.804**

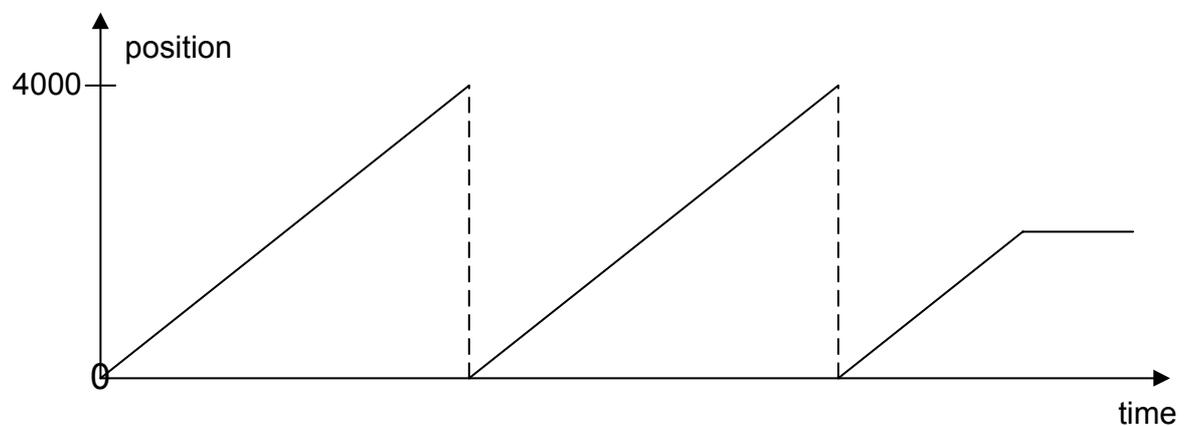
- (2.804) The overflow mode can be activated by command 16:
In this mode, the overflow register (1xy085) is taken into account for a positioning process and the actual position is set to zero if necessary. The set positions are given as absolute values. The mode is disabled by command 18.

Example program:

```
REGISTER_LOAD (121001, 1)
REGISTER_LOAD (121085, 4000)
REGISTER_LOAD (121001, 3)
;
REGISTER_LOAD (121001, 16)
POS (21, 10000, 500)
WHEN
  AXARR 21
THEN
  REGISTER_LOAD (121001, 18)
```
